(Bulletin for Statehouse, Capitol Mall Employees November 19, 2001)

Don't Miss the Moving Scaffolding

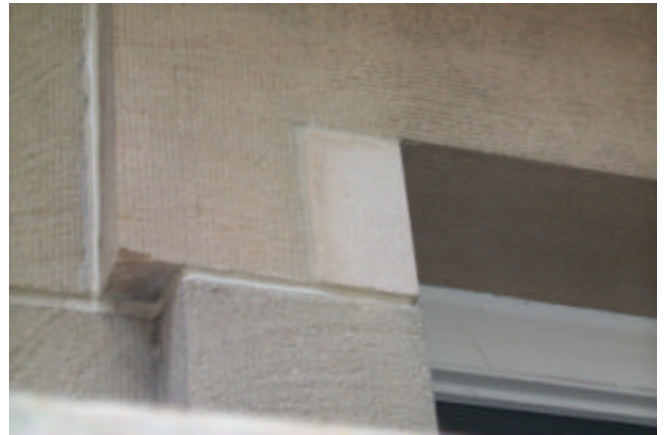
When A Stone Needs a 'Face Lift' — The Doctor Calls For A Dutchman ...

A carved dutchman, the lighter colored stone work in the center of the picture, is simply a piece of stone that is applied as a "patch" to the face of an existing stone. The stone can be a "carved dutchman" with rounded edges or an "ornamental dutchman" with decorative elements. The existing stone is removed and the dutchman is applied with epoxy mortar and/or pins (little steel rods). A carved dutchman is used as a patch, just as its namesake, the famous little Dutch boy in Holland, put his finger in the dyke and plugged it, saving the country. Dutchmen are used very sparingly in the Capitol – it is only when stones are chipped or fractured that the stone masons need to add them.

Over the past several weeks, as part of the exterior masonry repair, deteriorated mortar joints have been identified and removed. In addition, those stones needing repair or replacement are also being identified and measured so the dutchman stone facades, as featured in photo above, can be manufactured.

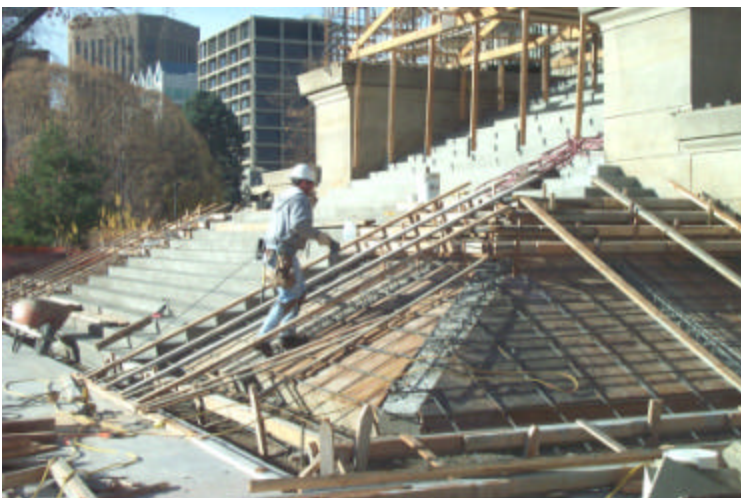
Photo at Left: Worker adjusts end sections of wooden forms in preparation of pouring of new concrete into the corner sections of the East Steps.

Jan Frew tells us that it appears the last pour of the concrete on the corner section of the East steps will have to be torn out and re-poured since this portion of the steps didn't meet standards.
